PCBs and Public Swimming Pools

Many municipally-run pools were built in the 1960s and 1970s using PCB-containing caulk. Decades later the PCB's are leaching into adjacent materials and structures.

By Robert Lowell,
Ileen Gladstone, and
Leslie Lombardo

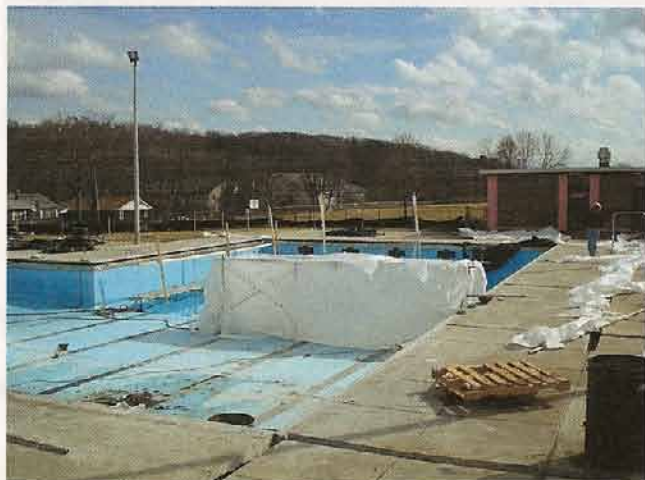
Remediation Activities at Shine Memorial Pool

- Removal of the paint coating the pools, gutters, and a portion of the pool walls from beneath the gutters.
- Removal of concrete adjacent to the main pool expansion joints.
- Removal of the water seal behind the main pool expansion joints and decking expansion joints, including concrete, caulking, and backer rod.
- Removal of the decking adjacent to the pool gutters.
- Excavation of the PCB-contaminated soil beneath the decking expansion joints and behind the pool gutters.
- PCB containing waste paint chips had been disposed of in a portion of the outlying property, and the paint chips along with the co-mingled soil was cleaned up to one ppm.

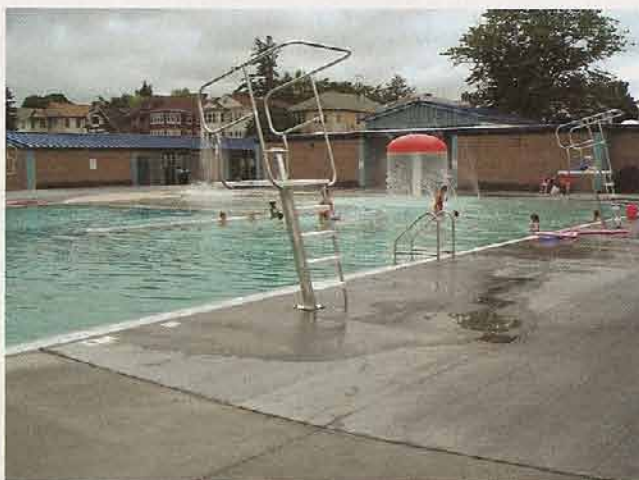
At left, the Casey Memorial Pool during rehabilitation. At right, the Casey Memorial Pool following rehabilitation and in use.

filter room, a separate filter building, and concrete decking. Initial remediation activities included removing paint from the surfaces of the main and tot pools, removing caulk from the main pool and decking expansion joints, and removing about 1.5 in. of concrete from both sides of the main pool expansion joints to a depth of 1.5 in. Following abatement, the surfaces of the pools were re-painted and the expansion joints were reconstructed. However, PCB-impacted concrete in the main and tot pools remained and soil beneath the decking expansion joints was impacted with PCBs from the caulk. The remaining impacted concrete and soil could not be remediated before the summer swimming season.

to remove the existing non-PCB paint and underlying PCB-impacted concrete from the main pool. However, these methods were not effective at removing the paint or sufficient PCB-impacted concrete beneath the paint. As a result, and to meet the schedule for reconstructing and opening the pool in time for the summer 2010 swimming season, the contractor was instructed to discontinue attempts at remediating the main pool concrete and to construct the new pool shell over the existing pool shell, thereby encapsulating the existing PCB-impacted concrete shell with a new concrete shell ranging in thickness from six to eight in. The tot pool concrete shell was demolished and transported offsite for disposal as PCB remediation waste.

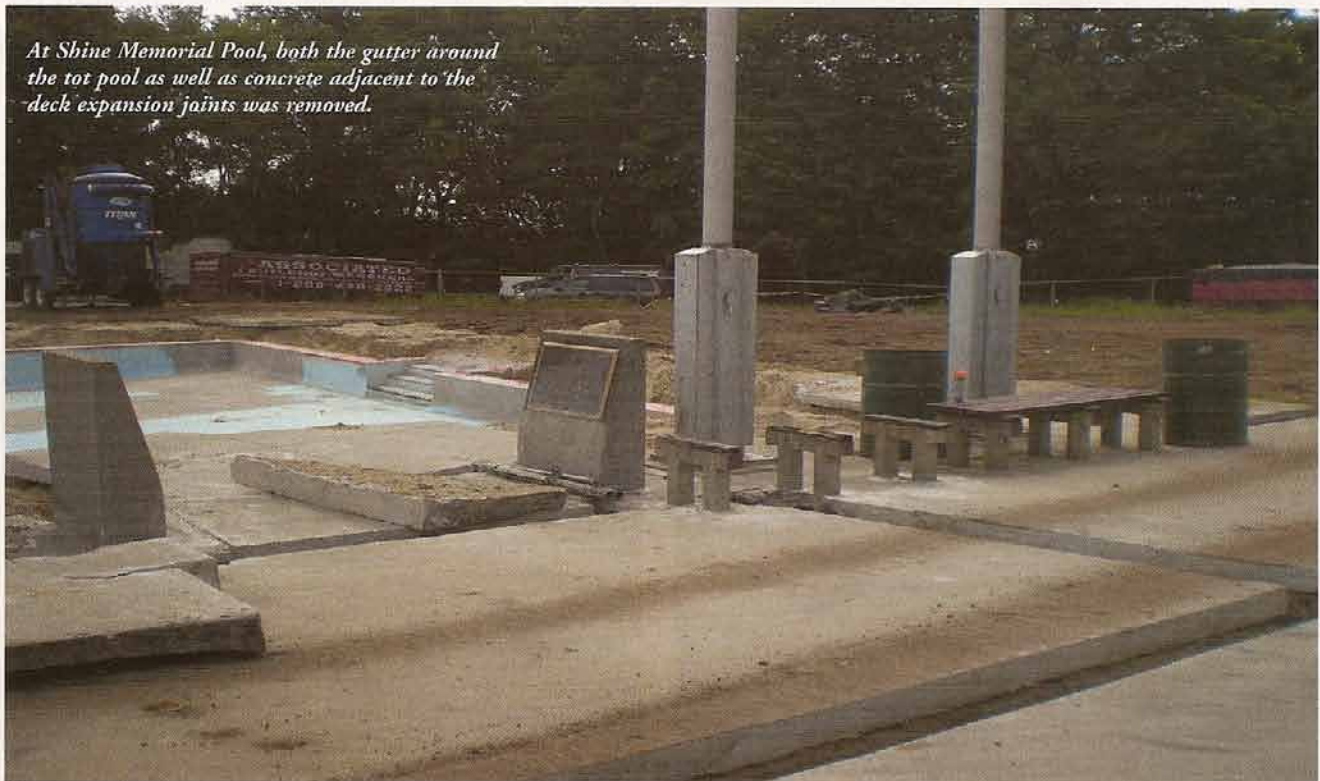
At Shine Memorial Pool, both the gutter around the tot pool as well as concrete adjacent to the deck expansion joints was removed.
